# Property Snagging Report Card

## 4 BEDROOM TOWNHOUSE

Project Name BXXX  
Dubai, Dubai .

First Name Last Name  
26/08/2025

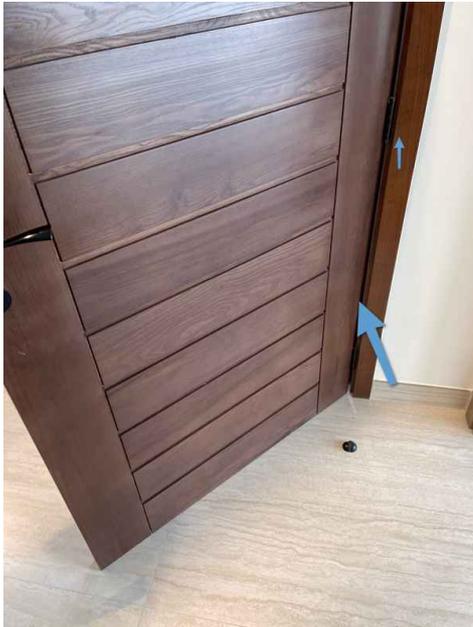
**HINGES LOOSE**

Loose hinges can cause door to stick or eventually fall out of place. This should be rectified by contractor.

Contact a qualified handyman.

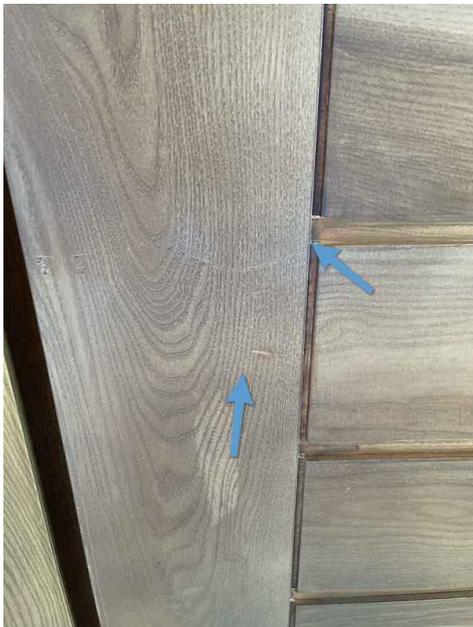
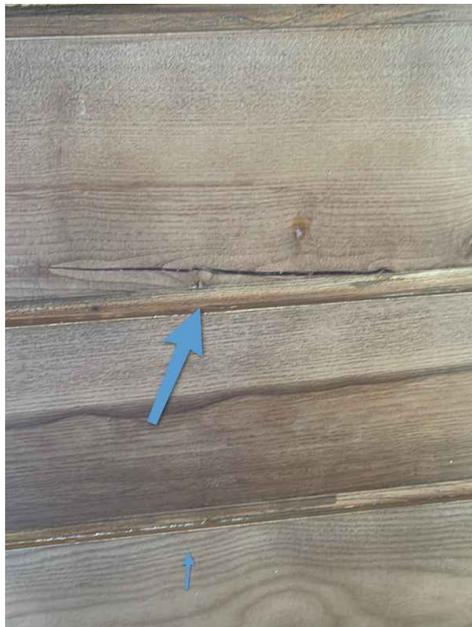
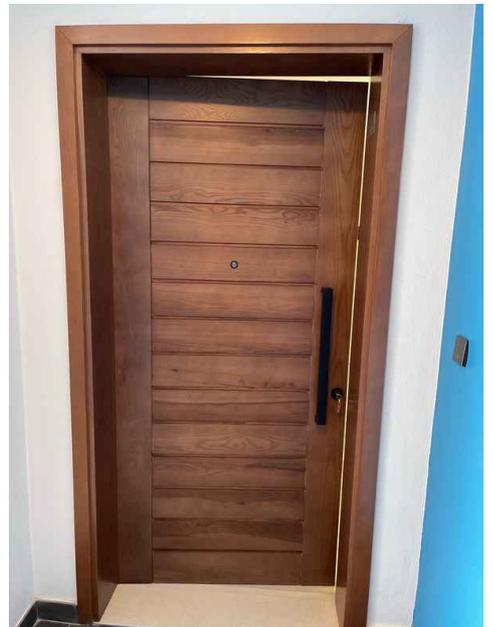
2.2.2 Doors

**MINOR SCRATCHES AND IMPACT DAMAGE**

The door was seen to have instances of impact damage and scratches. This should be redecorated.

Contact a qualified carpenter.

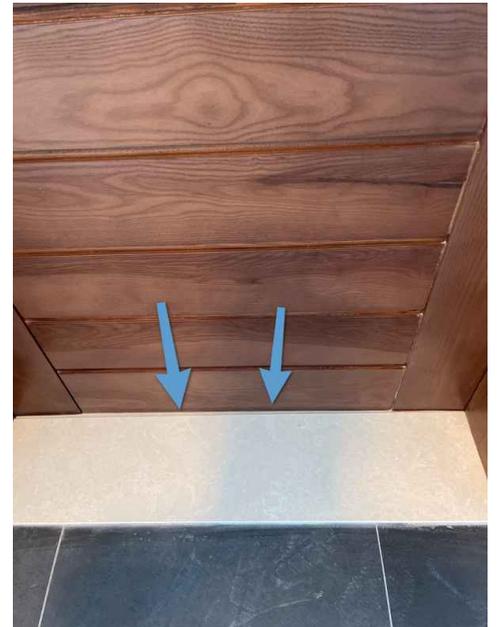
### 2.2.3 Doors

A large gap between the door and floor was noted, allowing external air and dust to enter the room. This should be checked and rectified.

Contact a qualified carpenter.

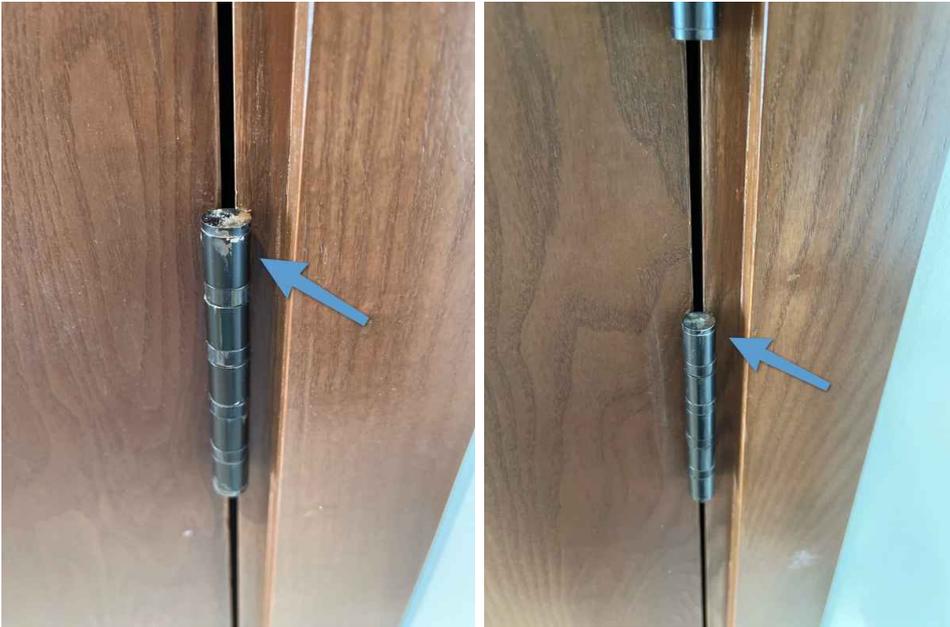
### 2.2.4 Doors

#### **CORROSION ON COMPONENT**

A door component was observed to have corrosion marks.

Contact a qualified professional.

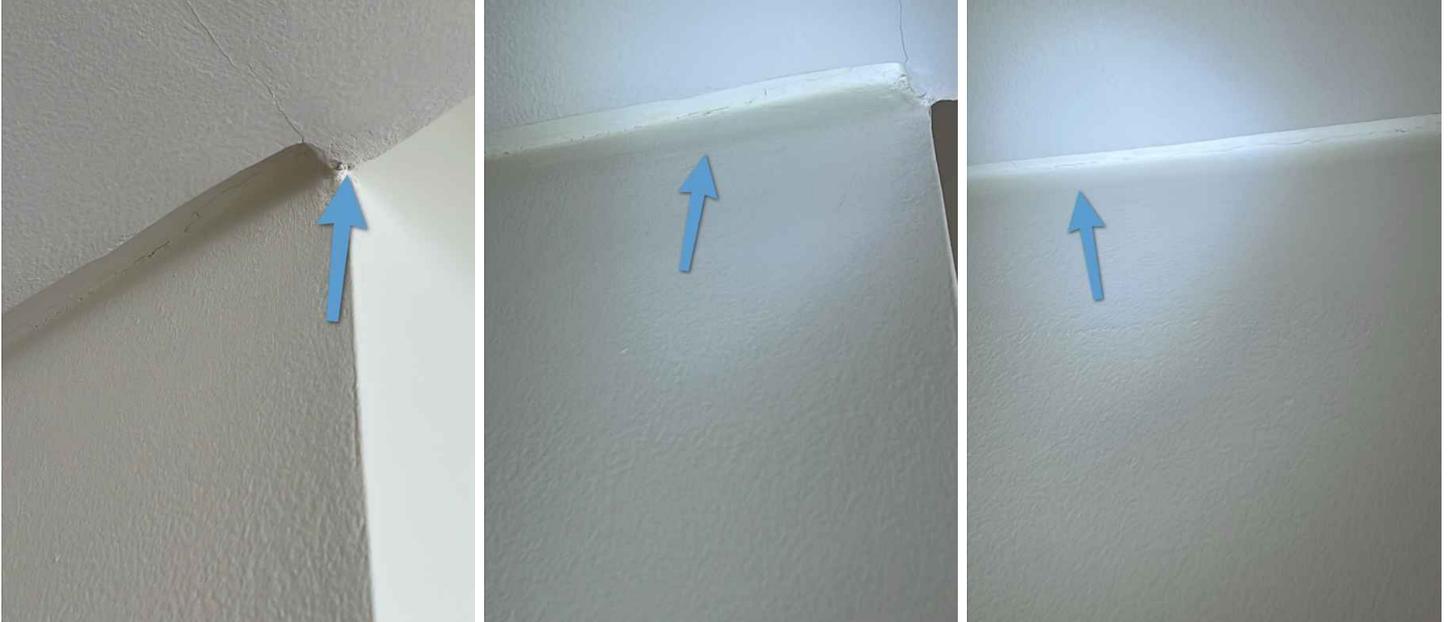
2.5.1 Ceilings

**HAIRLINE CRACKS**

The ceiling was discovered to have several small hairline cracks.

Contact a qualified painting contractor.

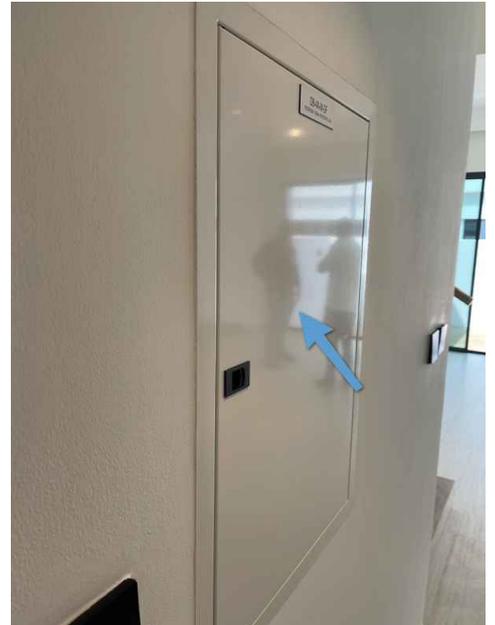
2.9.1 Electrical

**SCRATCH MARKS ON DISTRIBUTION BOARD**

Scorch marks were noted on the distribution board, indicating that there was an overheating issue that needs to be addressed.

Contact a qualified professional.

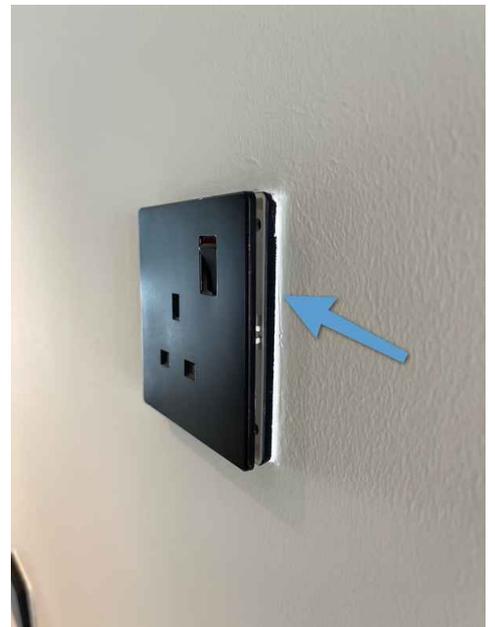
2.9.2 Electrical

**COVER PLATES DAMAGED**

One or more receptacles have a damaged cover plate. Replacement of the unit is recommended.

Contact a qualified electrical contractor.

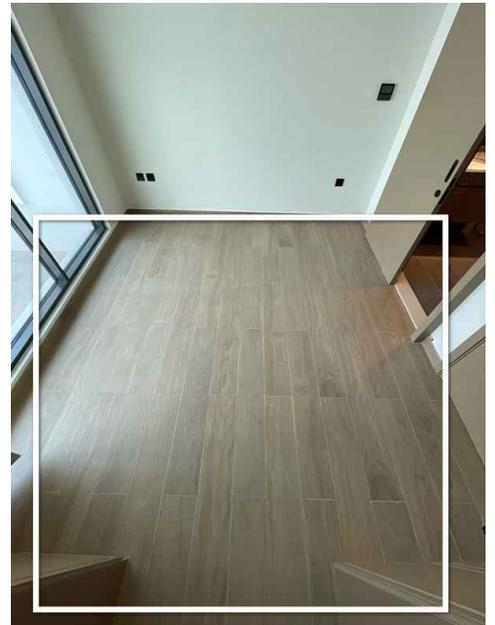
### 3.3.1 Floors

#### **FLOOR TILE COLOR SHADE DIFFERENCE**

The floor tiles were noted to have color shade difference. This needs to be checked and rectified by the contractor. Need to regrout

Contact a qualified flooring contractor

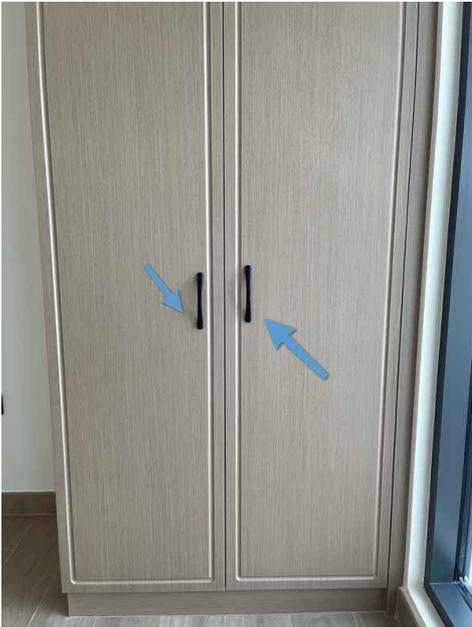
### 3.8.2 Built-In Storage

#### **MISALIGNED DOOR HANDLE**

The cupboard door handle alignment was discovered to be affected by inadequate installation, causing them not to close properly.

Handle misaligned

Contact a qualified professional.

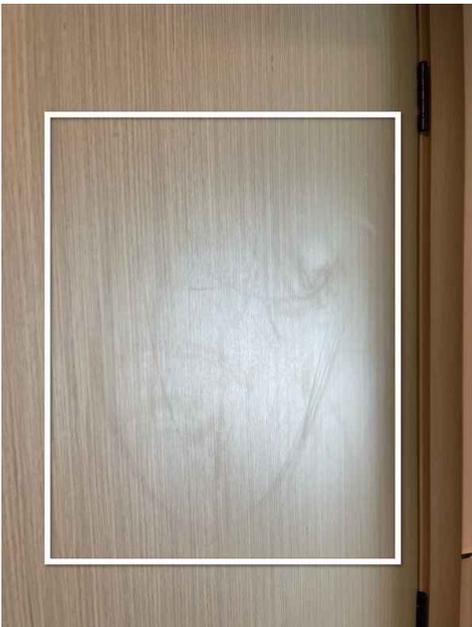
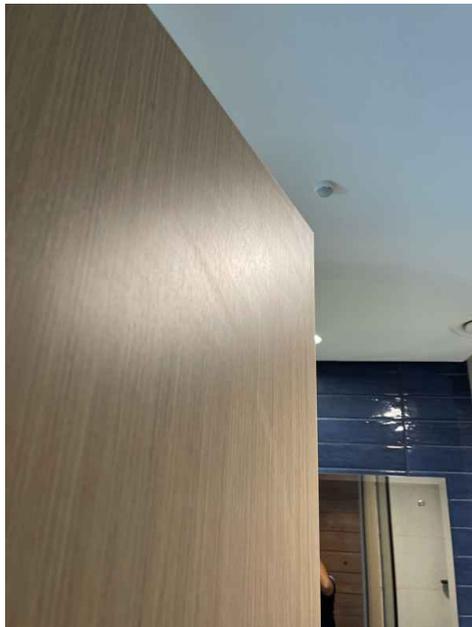
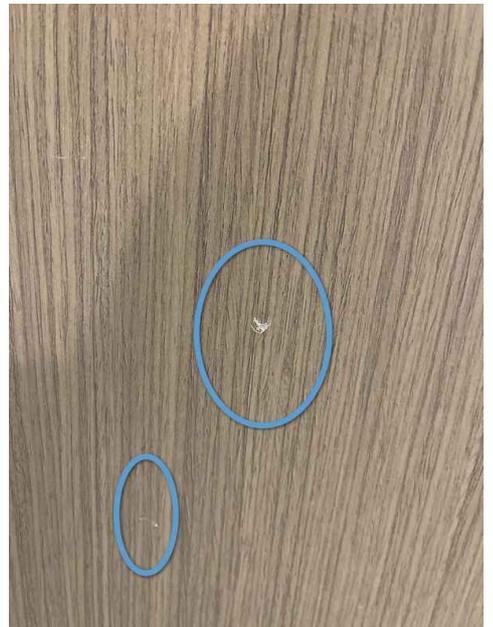
4.2.3 Doors

**MINOR SCRATCHES AND IMPACT DAMAGE**

The door was seen to have instances of impact damage and scratches. This should be redecorated.

Contact a qualified carpenter.

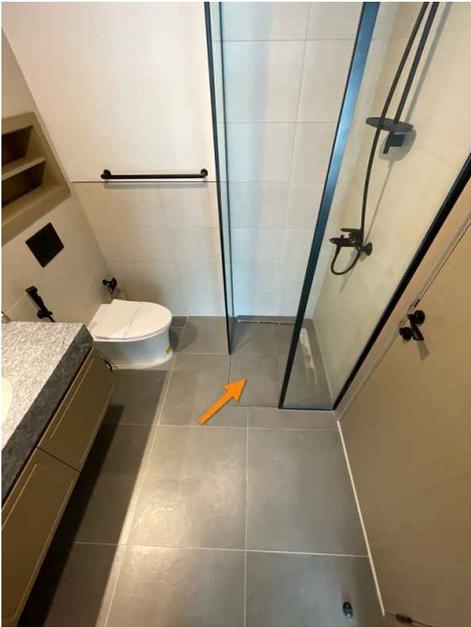
#### 4.3.1 Floors

### FLOOR TILE COLOR SHADE DIFFERENCE

The floor tiles were noted to have color shade difference. This needs to be checked and rectified by the contractor. Need regrout the shower

Contact a qualified flooring contractor

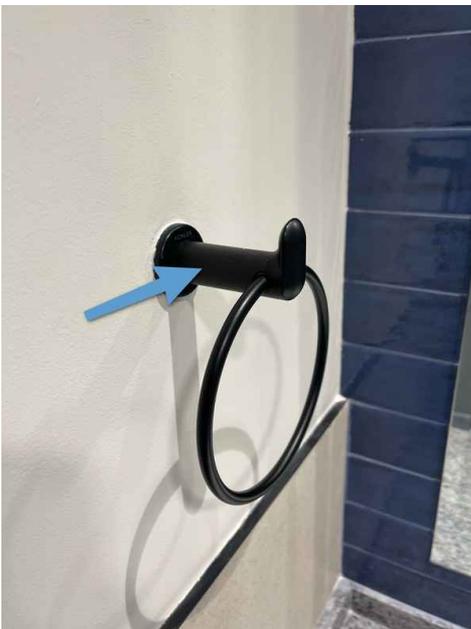
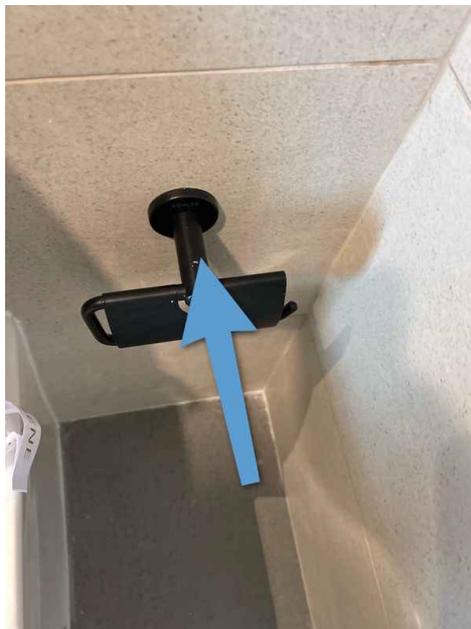
4.8.1 Sanitary Fixtures

**LOOSE SANITARY FIXTURE**

A sanitary fixture was loose.

Contact a qualified professional.

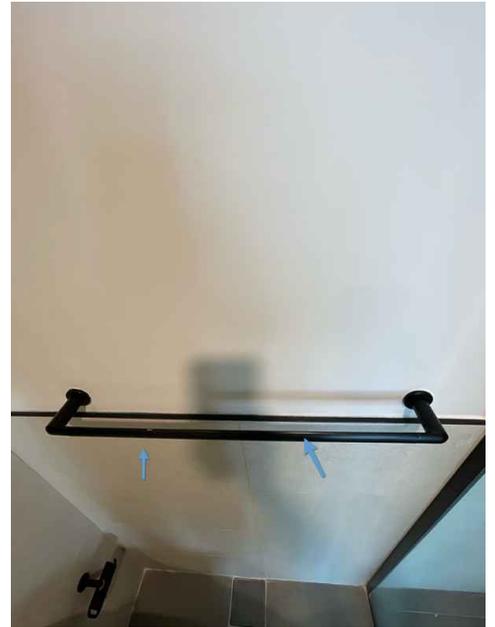
4.8.2 Sanitary Fixtures

**SANITARY FIXTURES PREMATURE CORROSION**

The sanitary fixture was discovered to be experiencing early corrosion.

Contact a qualified professional.

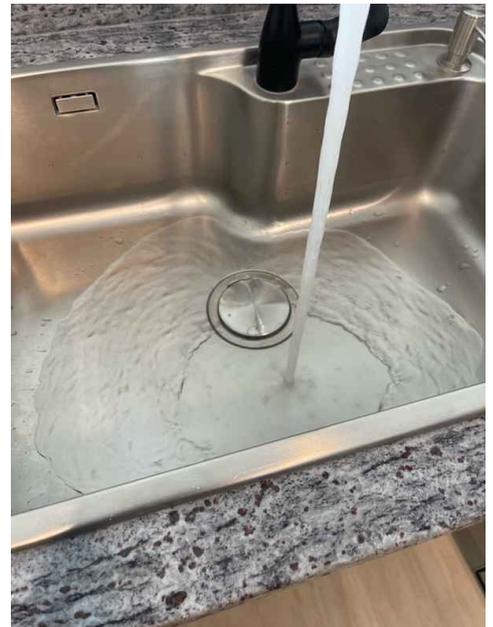
5.13.1 Plumbing internal

### DEFECTIVE WASHBASIN DRAIN STOPPER

Not working

Contact a qualified professional.

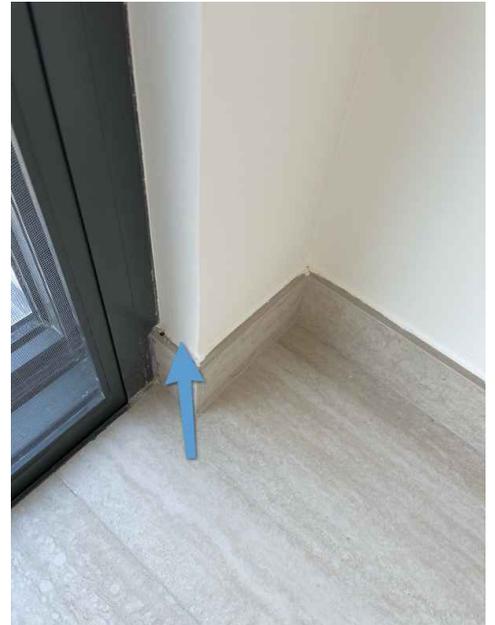
**CRACKED TILE**

A floor tile was found to be cracked. This should be replaced by the contractor.

Contact a qualified handyman.

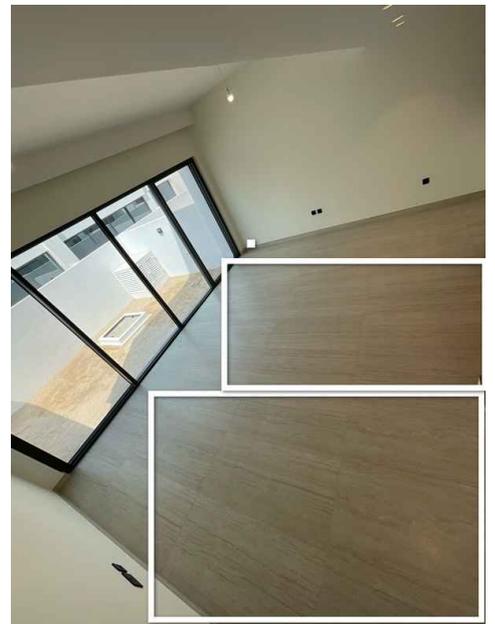
## 6.3.2 Floors

**FLOOR TILE COLOR SHADE DIFFERENCE**

The floor tiles were noted to have color shade difference. This needs to be checked and rectified by the contractor. Need to regrout.

Contact a qualified flooring contractor

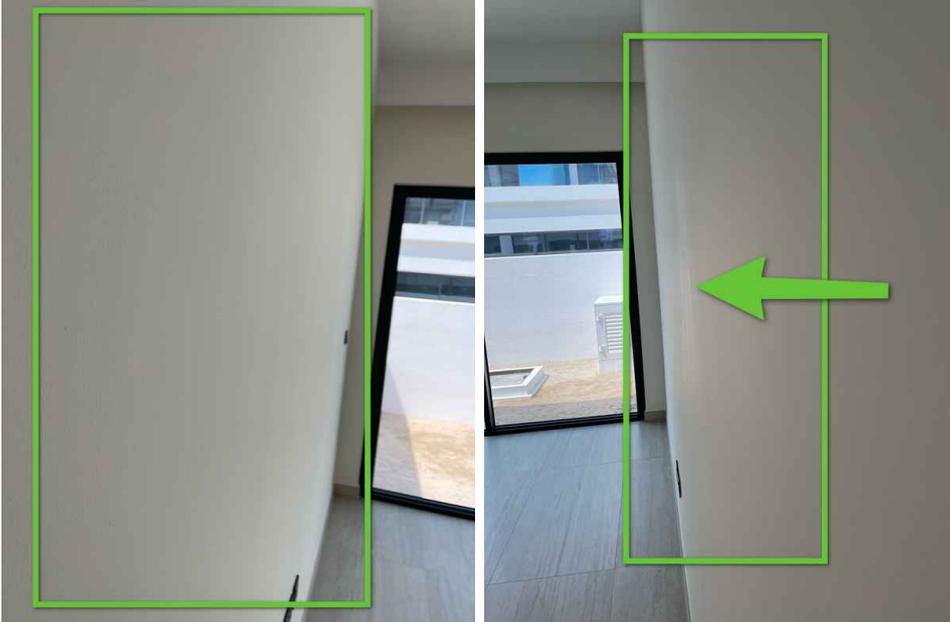
6.4.1 Walls

**POOR PATCHING**

Sub-standard drywall patching observed at time of inspection. Re-patching should be done.

Contact a qualified drywall contractor.

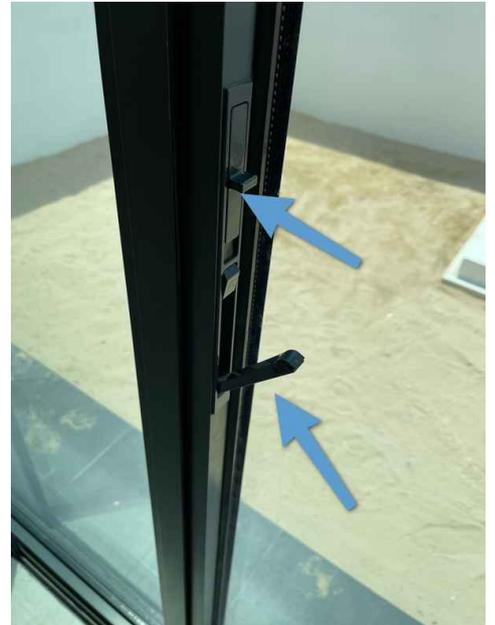
6.7.1 Sliding Doors

**DEFECTIVE LOCKING MECHANISM**

The mechanism for locking the sliding doors was found to be defective and was not shutting.

Lock not working

Contact a qualified window repair/installation contractor.

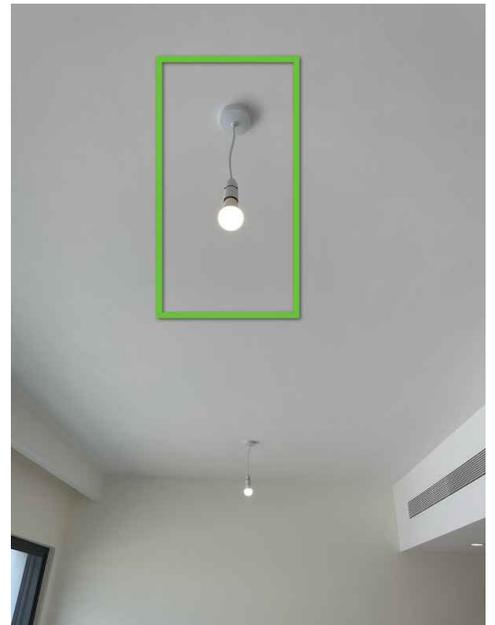
6.9.1 Electrical

An electrical fixture was noted to be positioned at an uneven angle.

Contact a qualified professional.

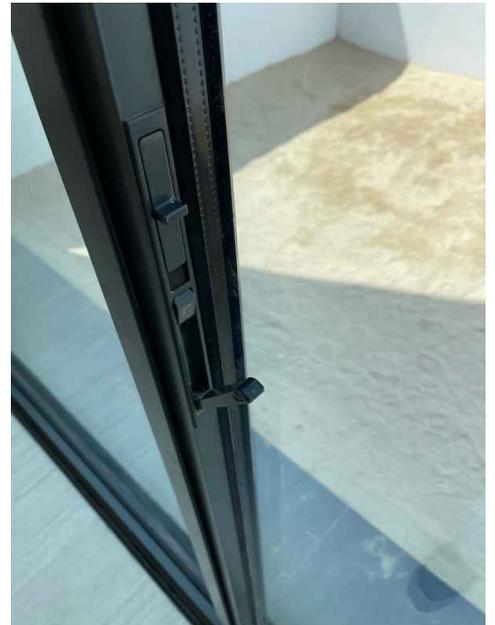
#### 7.7.1 Sliding Doors

### DEFECTIVE LOCKING MECHANISM

The mechanism for locking the sliding doors was found to be defective and was not shutting.

Contact a qualified window repair/installation contractor.

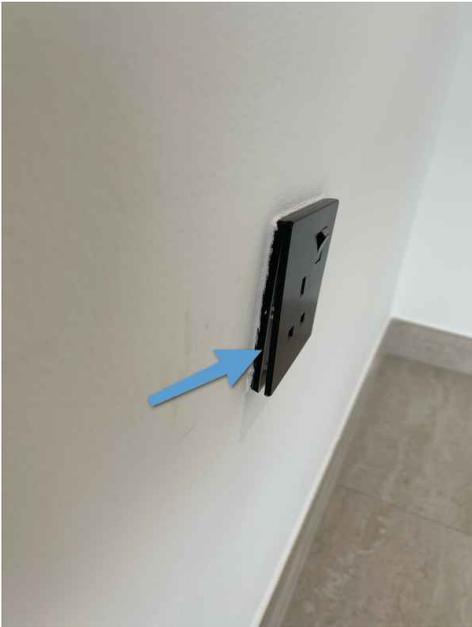
#### 7.9.1 Electrical

### ELECTRICAL FIXTURE AT AN UNEVEN ANGLE

An electrical fixture was noted to be positioned at an uneven angle.

Contact a qualified professional.

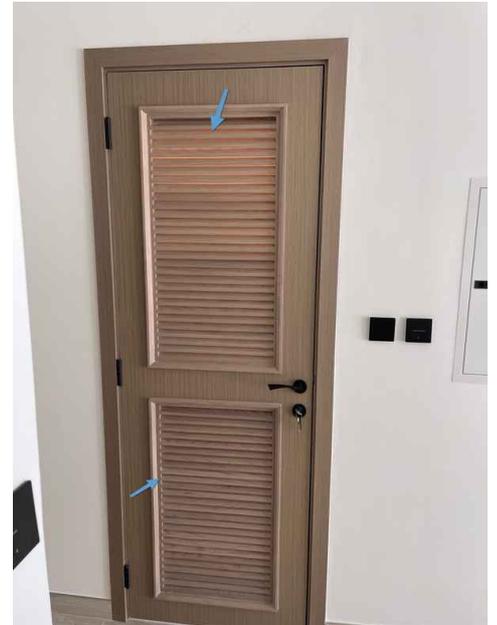
**MINOR SCRATCHES AND IMPACT DAMAGE**

The door was seen to have instances of impact damage and scratches. This should be redecorated.

Contact a qualified carpenter.

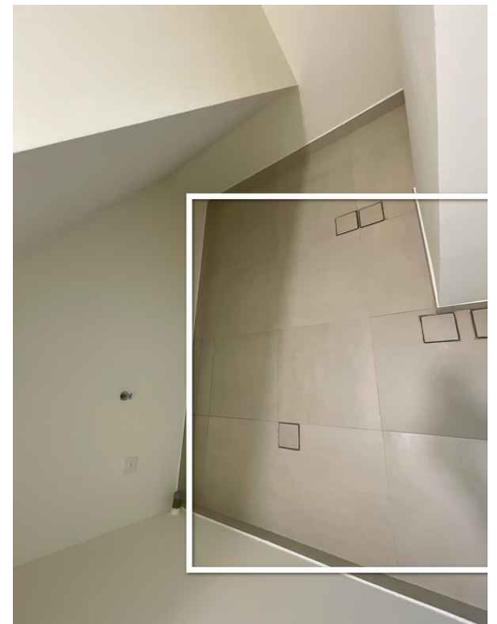
## 8.3.1 Floors

**FLOOR TILE COLOR SHADE DIFFERENCE**

The floor tiles were noted to have color shade difference. This needs to be regouted

Contact a qualified flooring contractor

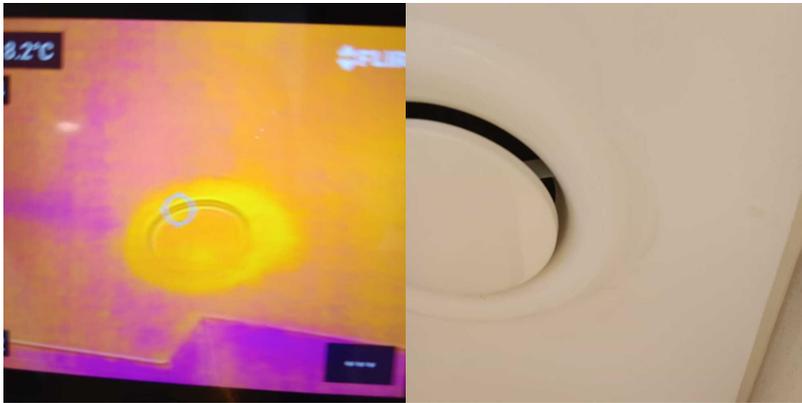
There are possible signs of fungi growth on ceiling. Dampness observed around exhaust area

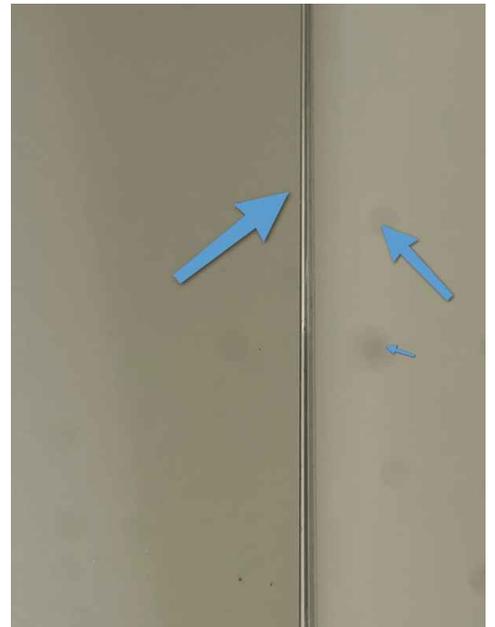
#### 12.4.2 Walls

The painting was observed to have flaws due to substandard craftsmanship, featuring excess paint stains and inadequate detailing.

Contact a qualified painting contractor.

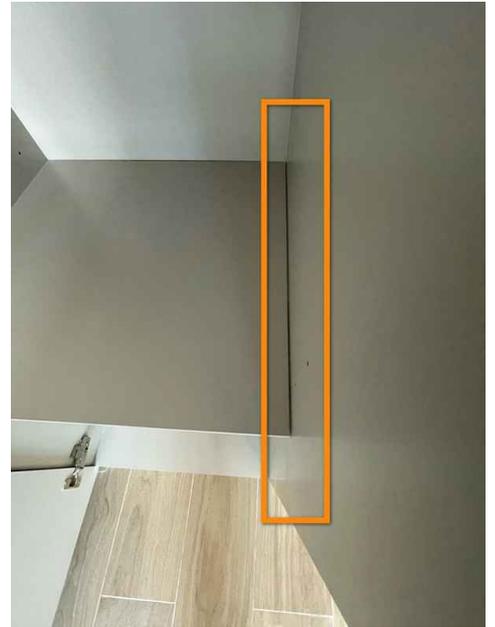
The installed unit was discovered to be experiencing issues due to inadequate craftsmanship, with termination gaps present between the side panel and wall connection.

Joint gap

Contact a qualified professional.

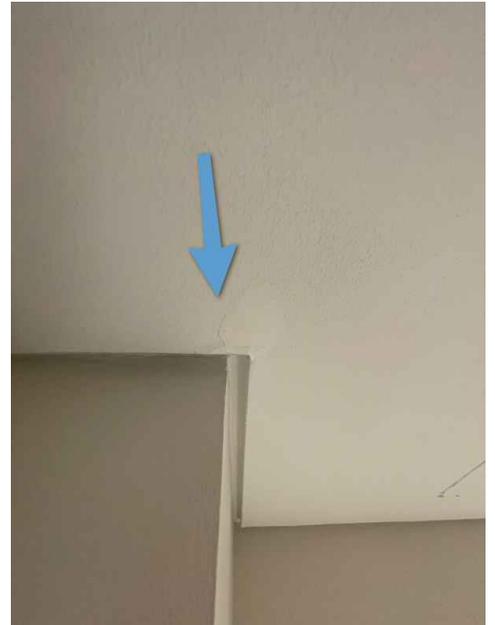
13.5.1 Ceilings

**STAIN(S) ON CEILING**

There is a stain on ceiling/wall that requires repair and paint.  
Source of staining should be determined to prevent further damage to the material.

Contact a qualified professional.

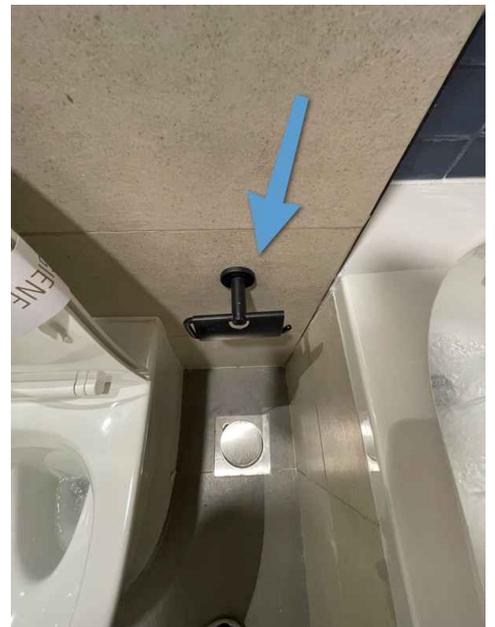
13.8.1 Sanitary Fixtures

### **LOOSE SANITARY FIXTURE**

A sanitary fixture was loose.

Loose

Contact a qualified professional.

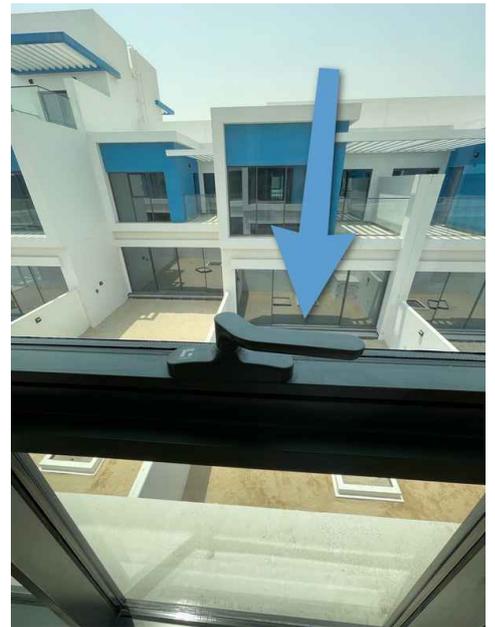
**DEFECTIVE LOCKING MECHANISM**

The mechanism for locking the window was found to be defective and was not shutting.

Loose

Contact a qualified window repair/installation contractor.

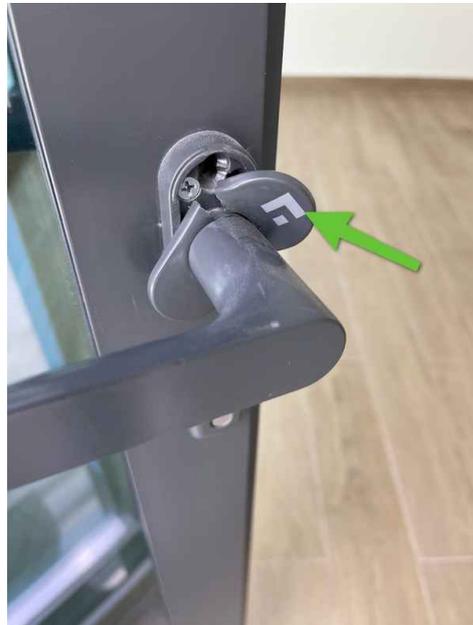
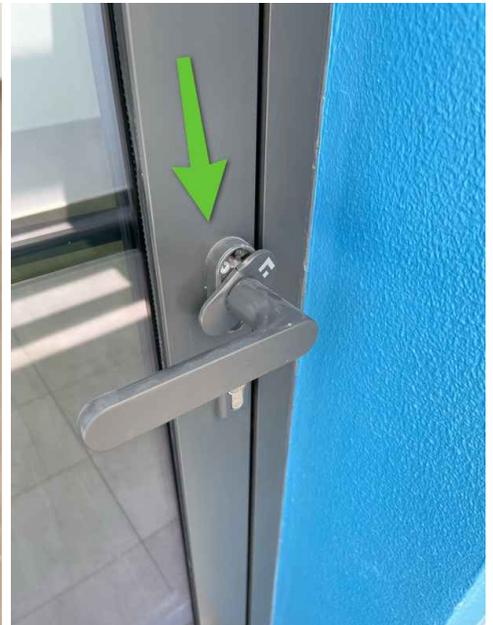
**DEFECTIVE LOCKING MECHANISM**

The mechanism for locking the sliding doors was found to be defective and was not shutting.

Latch broken

Contact a qualified window repair/installation contractor.

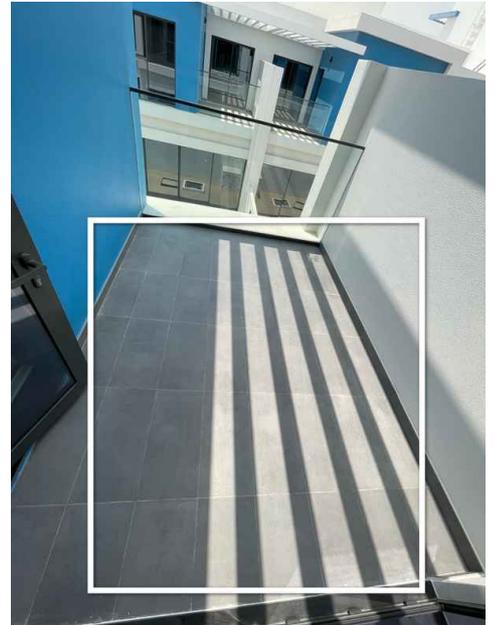
The floor tiles were noted to have color shade difference. This needs to be checked and rectified by the contractor. Need to regrout

Regrout

Contact a qualified flooring contractor

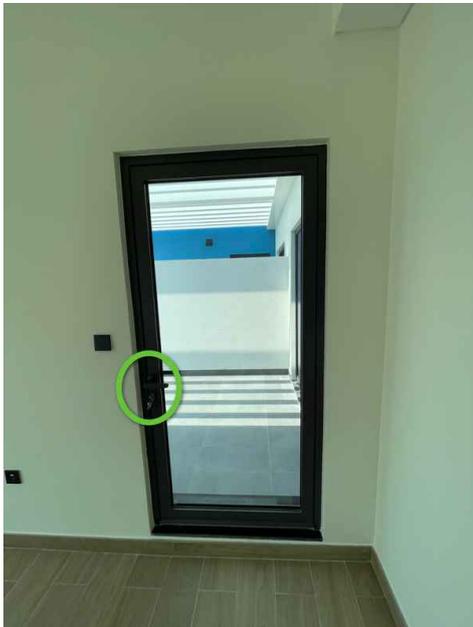
16.6.1 Sliding Doors

**DEFECTIVE LOCKING MECHANISM**

The mechanism for locking the sliding doors was found to be defective and was not shutting.

Lock to check

Contact a qualified window repair/installation contractor.

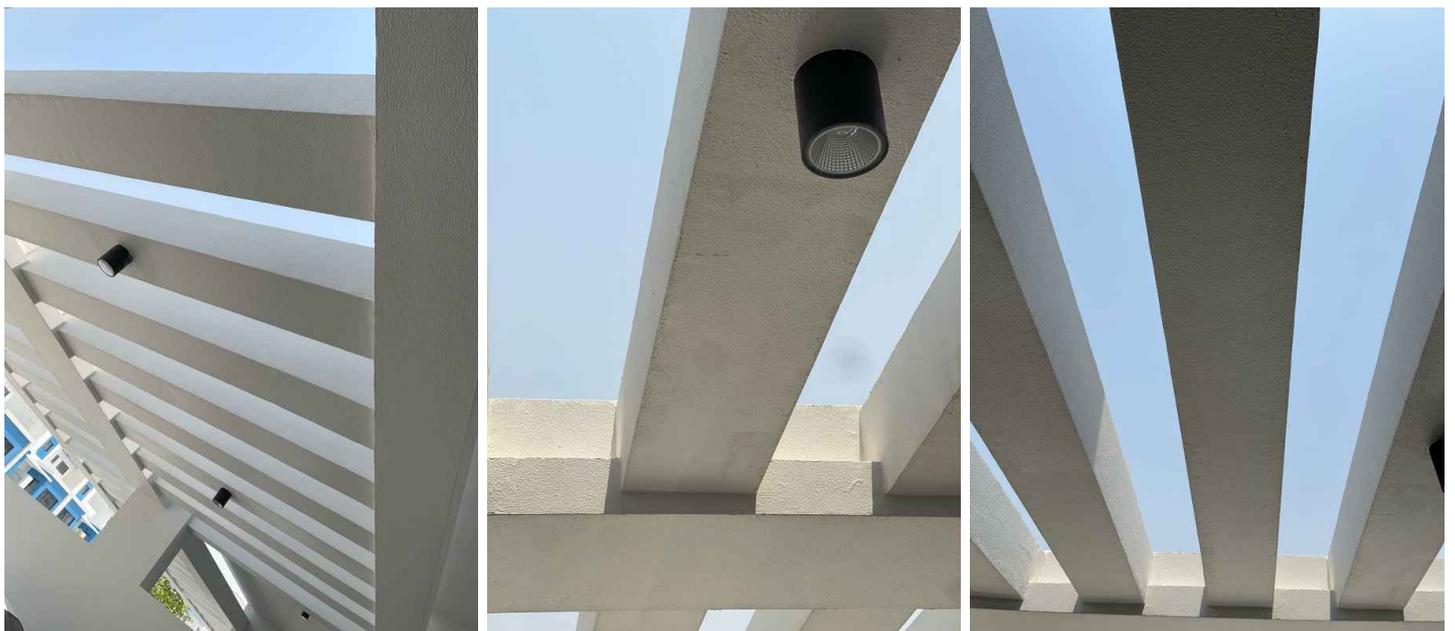
The ceiling of the garage was discovered to have inadequate finishing and paint quality.

Contact a qualified professional.

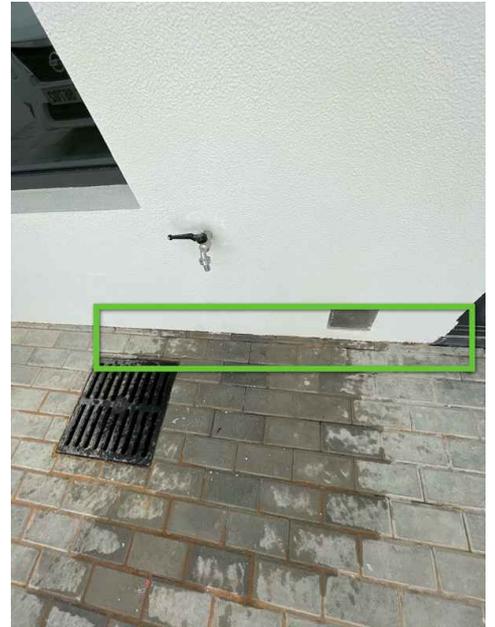
17.2.1 Floor

**CRACKING**

Cracking visible in the garage floor. I recommend a structural engineer to evaluate.

Minor gap

Contact a qualified structural engineer.

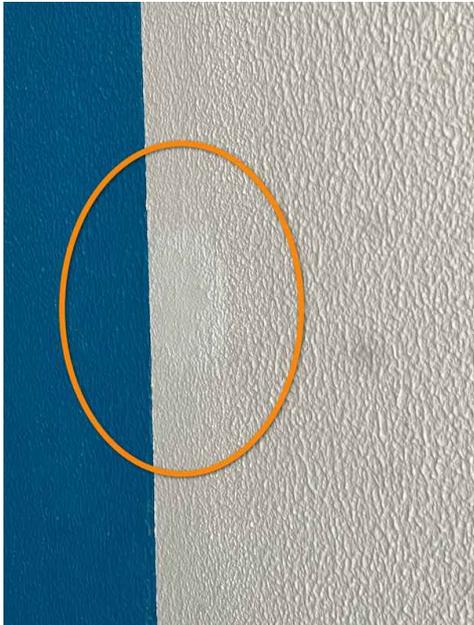
17.3.1 Walls & Firewalls

The garage wall was discovered to have inadequate finishing and paint quality.

Contact a qualified professional.

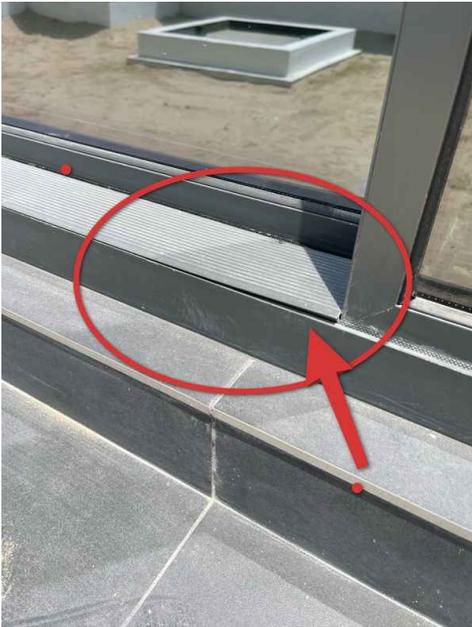
## 18.5.1 Walkways and Patio

**POOR INSTALLATION OF INTERLOCK WITH GAPS**

Contact a qualified masonry professional.

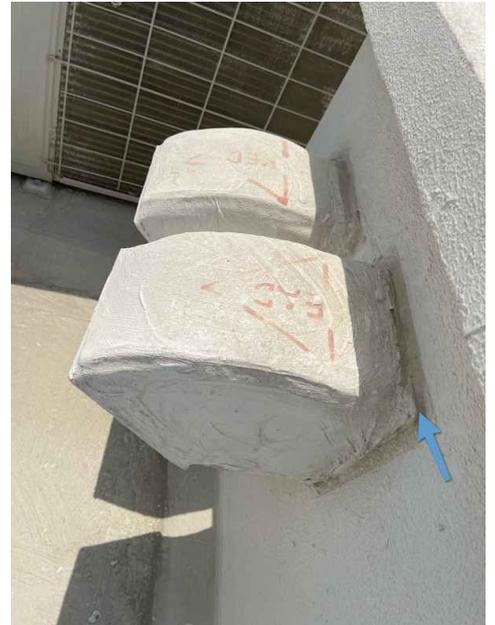
Delamination

Contact a qualified roofing professional.
